Engineering Bulletin: 061602

Subject: 4500 Series Deep Pocket Dies

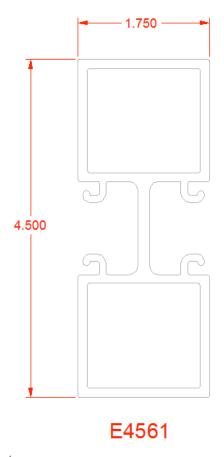
Customers have experienced issues with having to recut transom glass down while using 4500 Series Storefront Entrances with transoms. This problem was caused by having two shallow glass pockets facing each other due to the way they where fabricated. To aleviate this issue, we have introduced two new extrusions to have deep pockets on both sides as our standard offering.
